锅炉下集箱的失效分析

[摘要] 锅炉右下集箱产生了很多环状裂纹和三个渗水点,同时顶棚水冷壁管塌陷。通过对左右下集箱、顶棚水冷壁材质的金相组织分析,对锅炉结构及水循环的分析,得出此锅炉下集箱失效的原因。

某厂运行中的 SHL6.5×2.45 型锅炉,

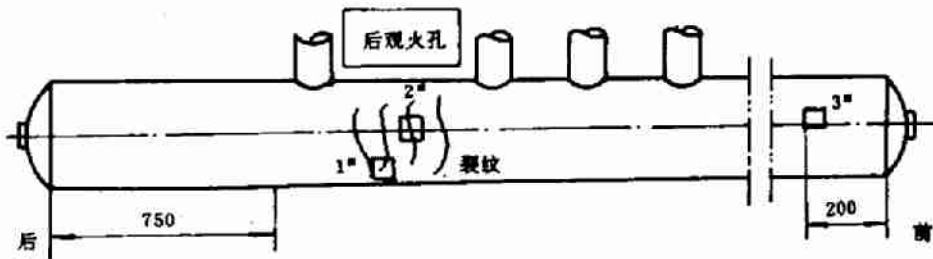
图1 下集箱尺寸及裂纹位置

系改造型锅炉,即把下集箱的后段加长了750 mm,如图1。

在运行十年后的定期检验中,发现右侧下集箱的后段,对应后观火孔的位置,其向火面在650×100 mm的范围内,有很多环状裂纹和三个渗水点。见图2。同时发现顶棚水冷壁塌陷。下陷的深度为75 mm,要求分析其失效的原因。

处理办法有两种,一种把下集箱加长部分去掉;第二种就是在下集箱加长段增添水冷壁管。参 考 文 献

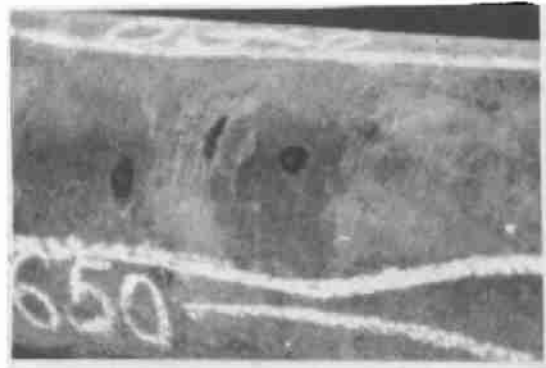
图2 环状裂纹和渗水点

右下集箱产生裂纹的部位,正处于后观火孔的位置,操作人员经常打开孔门观察炉内炉火燃烧的情况和用炉钩子钩煤渣。温度的变化,产生冷热交变应力,最终产生热疲劳裂纹。

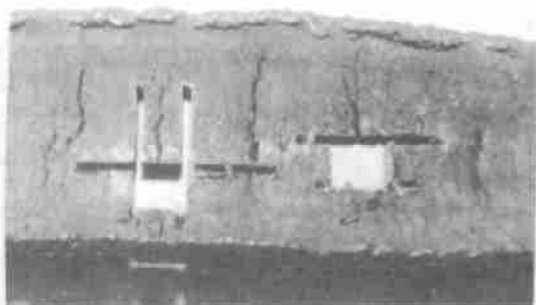
图3 下集箱内壁裂纹形状
(白色空白是取金相试样的位置)

2.1.1 宏观检验 把具有环状裂纹的右侧下集箱管段割开,发现管壁内侧,布满了大大小小深浅不等的环状裂纹,有的裂纹宽度为2 mm,此管壁外侧裂纹更深更多。三个渗水点就是环状裂纹穿透管壁造成的。如图3。

水分层的状况。蒸汽的比重小,在集箱的上面,水的比重大,沉在集箱的底部,而蒸汽的导热系数小,导致集箱顶部(即向火面)过热,强度降低,出现腐蚀裂纹。其裂纹的特征如图3上所显示的那样,裂纹成群产生,在管子的顶部横向分布;微观象图4上显示的那样,裂纹穿晶分布,较少分枝。因为冷热交变应力小于腐蚀裂纹,裂纹尖端呈圆钝状^[1]。其金相组织发生变化,珠光体发生球化,随着时间的增长,球化加剧,最后发展为石墨化。

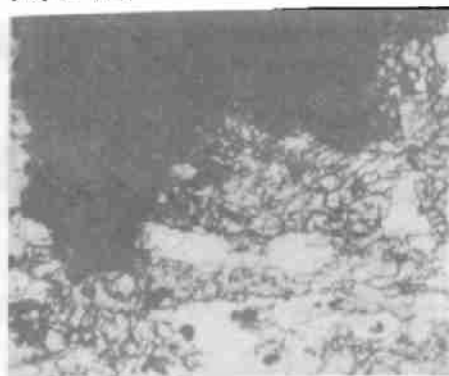
图4 1"样×250
组织:铁素体+碳化物+石墨(晶粒大小不均)

在裂纹尖端取一个试样,编号为1"样;
在渗水点处取一个试样,编号为2"样;
在前段,距端点200 mm处取一个试样,编号为3"样。

集中,特别危险的是石墨呈链状分布时,在它的周围形成复杂的应力状态,使金属材料处于脆性状态^[2]。最终出现了一条条的环状裂纹,其金相组织出现了珠光体球化和石墨化。

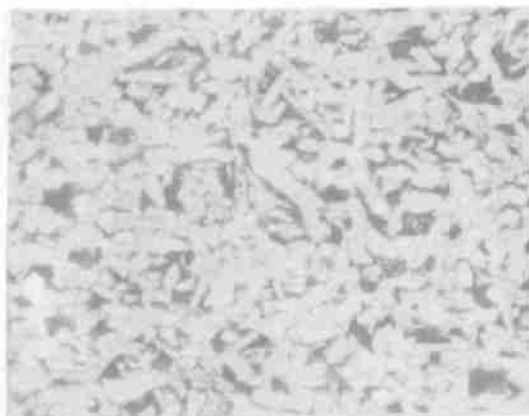
图6 3"样×100
组织:铁素体+珠光体+魏氏组织1级

3.1 被检验的下集箱和水冷壁均发生了组织转变,出现了过热组织—魏氏组织。说明此台锅炉发生过缺水事故。

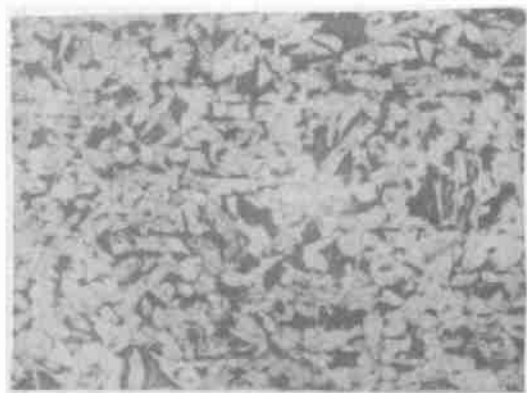
图7 4"样×100

a 金相试样取样位置:与右侧下集箱上的2"样,3"样相对称的位置,各取一个金相试样,编号分别为4"样和5"样。

组织:铁素体+珠光体+魏氏组织1级

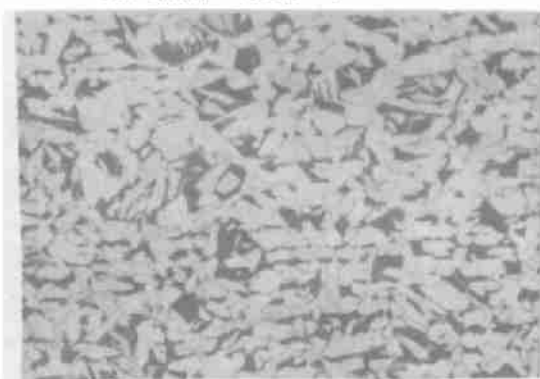
图8 5"样×100

组织:铁素体+珠光体+魏氏组织1级

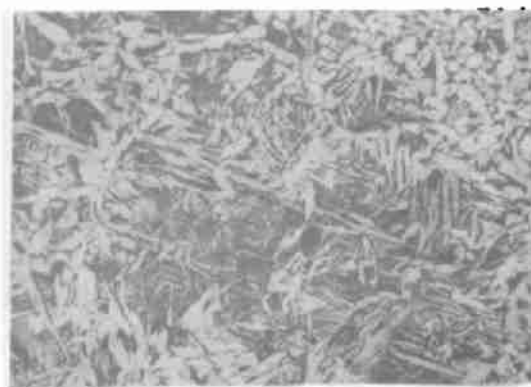
图9 6"样×100

2.3.1 宏观检验 表面发兰,氧化皮很厚,厚达1.5 mm。

组织:魏氏组织5级+铁素体+珠光体

处,在其向火面取一个试样,编号为6"样;在其背火面取一个试样,编号为7"样。

锅炉运行时,由于锅内缺水,管子的壁温急骤升高,超过金属材料的相变温度(下集箱和水冷壁的材质均为20"钢,其相变临界温度为855℃)。高温下,金相组织发生相变,珠光体转为奥氏体。当一定的冷却速度冷却降温时,奥氏体组织转变为魏氏组织。魏氏组织是一种过热组织,它的出现,会使金属材料的力学性能下降,严重地影响了锅炉的安全性。造成了顶棚水冷壁管塌陷。

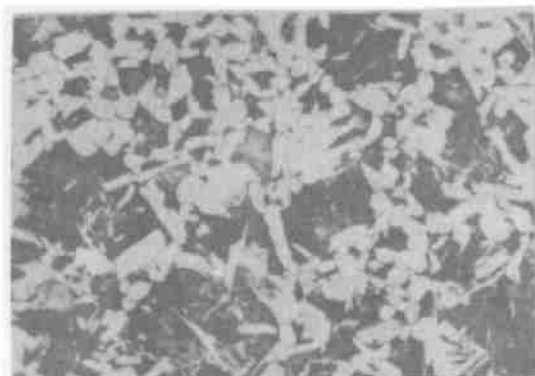
图10 7"样×100

组织:铁素体+珠光体+魏氏组织3级
