循环流化床锅炉的磨损及防磨措施

(济南锅炉厂, 山东 济南 250023) 谌玉良 张 同 张春柳 李子明

循环流化床锅炉的磨损及防磨措施 = **Wear of Circulating Fluidized-bed Boiler Elements and Wear-prevention Measures**

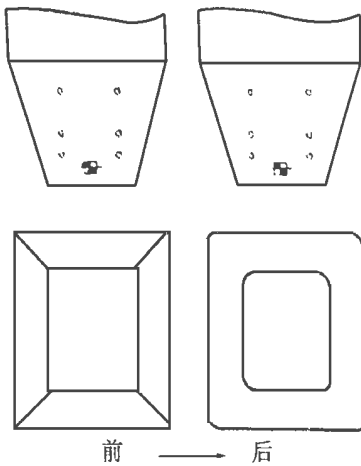
图 1

2.1.1 床体燃烧室部分因颗粒直径大, 物料浓度高对炉壁造成的磨损最严重。若风室和床体为非水冷壁结构, 因炉墙太厚造成的热应力和物料的磨损常常导致墙体内表面产生脱落和出现裂纹。通过把拐角处用圆角代替方角的方法很好地解决了这个问题, 如图 1 所示。为保证床体的温度, 床体的上部常保持一定高度的卫燃带, 在炉墙与水冷壁的结合处磨损较严重, 如图 2(a) 所示。原因是该处的截面形状发生了变化, 导致烟气在此形成涡流区, 加速了管子的磨损。我们顺势利导, 把水冷壁下部的炉墙做成和膜式壁一样的截面, 使炉壁在垂直方向上没有截面变化。如图 2(b) 所示, 磨损大大减轻了。

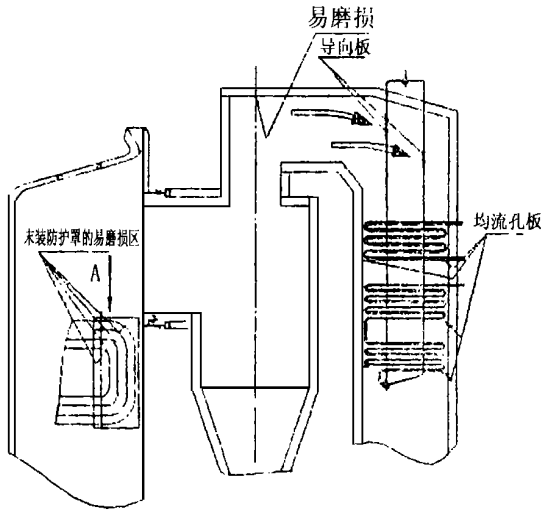
(A)炉膛中的屏式受热面
当屏如图 3 所示布置时,经观察发现弯头部位磨损相当严重,因屏式受热面横向间距很大,用常规保护结构是不可能的,后来采用了图 4 形式,在弯头处加装了耐磨合金板做成的保护罩,效果不错。芬兰 ALSTROM 公司生产的 410 t/h 的 CFB 锅炉的屏结构如图 5 所示,炉膛内不出现弯头,每一片过热器屏都有独立的两个集箱。这种结构单从防磨观点上看不失为一种好办法,显然它的缺点是使系统变得复杂,成本提高。

图 3 所示,转向室内设置导向板,避免了因离心

作用导致的局部灰浓度过高而造成的对吊管和尾部受热面的磨损。横置式过热器和经济器的弯头的保护有多种方式,图 6 的缝板结构和孔板结构无疑是比较理想的结构形式。
