# 某船主锅炉过热器管束爆管原因分析及解决措施

**摘要:** 针对某船主锅炉过热器管束的爆管问题, 对管束材料、过热器结构及系统运行等方面进行试验、计算及分析讨论, 明确了爆管产生的原因——过热器集箱隔板装置因运行操作不当, 突然承受大的压差而变形, 导致蒸汽短路而爆管。为此, 提出了解决措施, 消除了产生爆管的因素。

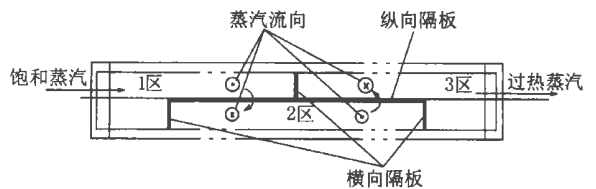
图2 过热器集箱内部隔板装置

从4次爆管所伴随发生的现象来看,每次均有程度不同的集箱内部隔板装置变形现象发生。隔板装置将过热器集箱分成3个空间,确保蒸汽沿规定的流程流动。一旦隔板装置脱落或变形,蒸汽则不再沿管束流动,而出现短路。这样势必造成流经过热器管束内的蒸汽量大为减少,导致管壁温度升高至  $740^\circ\text{C}$  以上而爆管。由于部分蒸汽短路,未按流程流过受热面管束,故过热蒸汽温度较正常运行时偏低,这就找出了每次爆管前过热蒸汽温度比正常运行时低  $60^\circ\text{C} \sim 100^\circ\text{C}$  的原因。

的压差迅速增大,远远超过隔板装置设计的强度极限,首先在最薄弱处造成隔板变形。隔板装置的作用是作为阻隔蒸汽沿规定的流程流动,因此实际设计中不能作为受压元件考虑。作为结构件,该隔板装置仅能承受 0.3 MPa 的压差。由于运行操作不当而造成的 3 MPa 压差,显然是隔板装置无法承受的。

(1) 过热器集箱隔板装置设计时虽然不作为受压件考虑,但作为结构件其在承受压力冲击方面的安全系数偏小。原设计隔板装置可承受 0.3 MPa 的压力,可满足正常工作时承受每个流程最大为 0.1 MPa 流动阻力的压力条件,但若满足某些突发或不规范操作所带来的不利影响,却略显不足。为此,对隔板装置的材料、结构重新进行了调整和加强,使

得隔板装置的承压能力提高到 0.5 MPa,增大了安全系数。
