耒阳电厂 200MW 汽轮机滑负荷原因分析及调速系统改造

摘 要:通过对调速系统的使用分析,找出 200 MW 机组采用高速弹性调速器为敏感元件的机械液压式调速系统滑负荷和负荷阶跃产生的原因。采用技术改造方案消除了调速系统滑负荷和负荷阶跃现象。

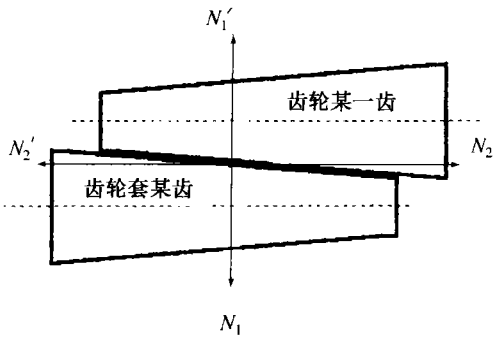
图 1 齿面磨损示意图

200 MW 机组转子的死点是 2 号轴承座的推力瓦, 高、中压缸的汽缸死点在中压缸的排汽缸的中部, 冷热态开机, 高中压缸高压转子向前膨胀。高压缸正常差胀为 3 mm 左右, 那么在转子温度低, 高压缸的差胀较小或在负数的范围, 齿轮组的齿轮面接触长度短, 磨擦其端部。停机过程中转子冷却速度快, 同样磨损齿轮的端部。随着开、停机次数的增加, 齿轮端部的磨损大于中部与后部, 于是齿面的磨损就变成非均匀性磨损, 从齿尖往下看变成一个楔形状, 如图 1 所示。

齿与齿之间的力传递除了一圆周方向力之外, 还存在一个轴向分力。随着机组运行时间的增长, 齿面磨损成楔形, 就使联轴器产生一个指向机头方向的轴向推力。按生产厂设计, 主油泵的推力应该是由调速系统的调速器滑阀组的 2 号滑阀喷油口, 直接将油喷到高速弹性调速器上, 高速弹性调速器与主油泵轴连成一体, 这股高速压力油的喷射使主油泵的轴向推力指向高压缸方向, 使主油泵推力瓦工作面承受推力。由于齿形联轴器的磨损产生一个指向机头方向的附加轴向推力, 结果改变了主油泵推力瓦的工作状态, 由非工作面工作。实践证明往机头方向轴向推力比较大, 这是导致推力瓦的非工作面磨损的主要原因。

原齿形联轴器为 55 型, 材质为 25CrMoV。齿面硬度 HRC20 左右, 偏低。现更换为 69 型, 材质为 38CrMoVAL, 表面渗氮处理, 硬度提高到 HRC45 ~ 50。从而改变表面接触强度, 使齿形联轴器的耐磨性提高, 使用寿命相对增长。

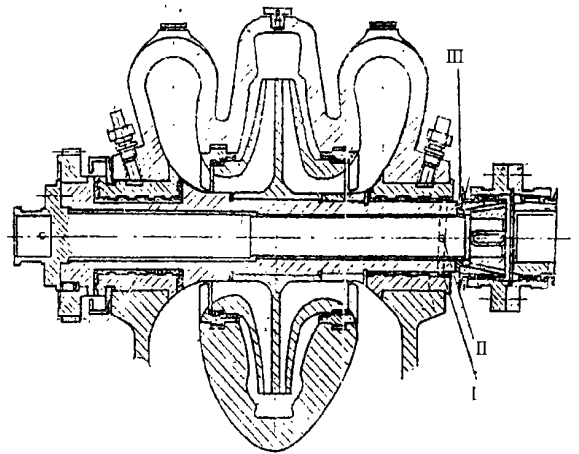
图 2 主油泵齿轮式联轴器的改造图

原结构内部齿间润滑油的供给有名无实, 解体时也发现齿间无润滑油痕迹。运行时属于干磨擦, 致使齿的啮合部分很快磨损咬合。为了改善齿间的润滑, 进行了如下改进。

I — 支持瓦改为环形油槽;

II — 空心轴直径为 8 mm 的 45°角孔; III — 铜套

分别在主油泵高压缸端的支承瓦, 主油泵的主轴的空心轴, 空心轴与主油泵侧联轴器之间, 采取了相应的改造, 见图 2。

(1) 主油泵的高压缸侧支承瓦的润滑油是从瓦座顶部引入进油管, 再通过上半瓦的上背开一条油槽直达上下瓦的结合中分面, 上瓦在对应的油槽中分面开一条进入瓦体内部油路。我们在上下两半瓦一端 5 mm 处, 开一条宽 8 mm 圆弧形, 深 2 mm 的油槽, 并在上瓦的圆环油槽与支承瓦中分面进油导通 (上半瓦中分面处去掉一部分乌金), 保证润滑油顺利进入圆环槽, 油量足够供应齿形联轴器。
