# 螺杆压缩机变速箱齿轮齿断裂原因分析

黎 军, 李庆瑞

(大庆石油化工总厂 机械制造公司, 黑龙江 大庆 163714)

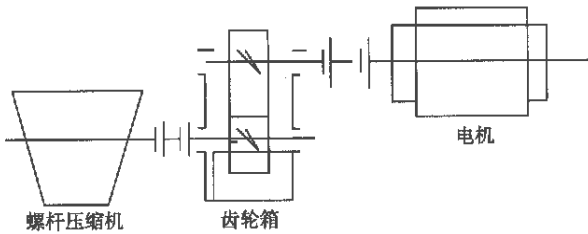
图 1

SC-801C 是我厂火炬回收节能装置的关键机组(见图 1)。

1994 年试车当中因轴承质量问题造成原变速箱齿轮严重损坏, 为抢工期重新加工。1995 年初开工, 运行一年左右, 该齿轮因加工精度不够造成齿啮合面磨损、噪音增大, 更换现齿轮后以上问题有所改变。运行至 1999 年 11 月初巡检时发现该齿轮箱振动有增大趋势, 1999 年 11 月 18 日因振动超标, 齿轮箱发出异常响声, 停机检修齿轮箱。

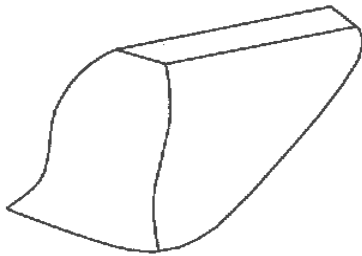
图 2

解体后发现大齿轮的两个齿损坏, 其中一个齿在根部成弧型断裂(如图 2), 另一个在旋转方向相隔两个齿从齿根裂开成燕尾形向轮毂中心发展, 由于成燕尾槽形虽裂开但没有脱落(如图 3), 使整个齿轮报废。

脱落齿面为均匀小波纹, 由工作面齿侧开始向齿内发展, 表明齿侧面应力大, 断口呈弧面状, 有明显的褐、紫色氧化膜颜色, 自齿侧面至断裂处颜色逐渐变浅, 说明断裂是从齿侧面开始逐渐向里延伸。

断齿侧面有较粗糙的刮痕, 表面发生过明显的磨损, 断齿侧面及附近齿侧面都有碾压痕迹, 说明载荷作用在该点上。

宏观断口可见清晰的疲劳纹, 这些条纹垂直于齿侧向方, 可明显找到位于齿侧根部圆角处的疲劳源, 说明裂纹是在拉压与冲击应变条件下不稳定发展的, 纹线还显示了齿断裂前, 疲劳裂纹已横向穿透了齿的大部分, 残留的危险断面是在大于其极限应力的冲击载荷的作用下瞬间断裂。

- (1) 加强对材料的质量和热处理质量的控制。
- (2) 保证齿轮的加工精度，提高齿面表面粗糙度的等级，对齿根进行喷丸处理，合理的修形，提高承载能力。
- (3) 定期检验润滑油质，保证油系统畅通。
