125 MW 机组锅炉给水泵液力偶合器损坏原因分析

刘贵平1,李献宝1,姬立钢2

(1. 焦作爱依斯万方电厂,河南 焦作 454172; 2. 焦作制动器股份有限公司,河南 焦作 454000)

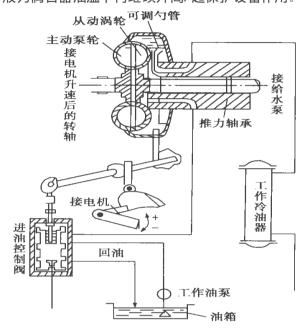
图 1 勺管与进油控制阀调节示意图

液力偶合器主要由泵轮、涡轮和旋转外壳构成,它是以液体动能来传递动力的叶片式液力传动装置。该液力偶合器采用改变工作油进油量(进油控制阀)的同时,移动勺管位置,调节出油量,使涡轮转速迅速变化。其联合调节见图 1。勺管泄放出的油去工作冷油器,经冷却后去进油控制阀,再由回油管回入联轴器底座上的油箱。这是因为锅炉给水流量增加时,一方面开大进油阀开度,另一方面在进油阀阀底下小弹簧的作用下,增加勺管泄油阻力,而减少泄油量,也就是进油阀同时起到控制进、出油量的双重作用,因而能迅速调节工作油量。转动外壳上装有4个易熔塞,当工作油温达到 130 °C时,易熔塞熔化,工作油由此孔排空,工作机械转速迅速下降,使

液力偶合器油温不再继续升高,起保护设备作用。
