1890/25.4 - YM4 型锅炉高温再热器 泄漏原因分析与对策

摘要: 针对某电厂国产 600 MW 超临界机组锅炉高温再热器出口异种钢焊口的泄漏情况, 采用直读式光谱分析仪 Spectro SortCCD TSC17 对高温再热器 T91/TP347H 异种钢焊接接头两端母材和焊缝进行化学成分分析, 并且在 LECO300 显微硬度计下观察和测量显微硬度, 利用 Axiovert 200 MAT 金相显微镜观察和分析金相组织, 同时综合管排的结构、爆口的特点进行全面分析, 得出高温再热器出口异种钢焊口泄漏的原因, 有针对性的提出治理方案, 因此对同结构的锅炉有很好的借鉴意义。

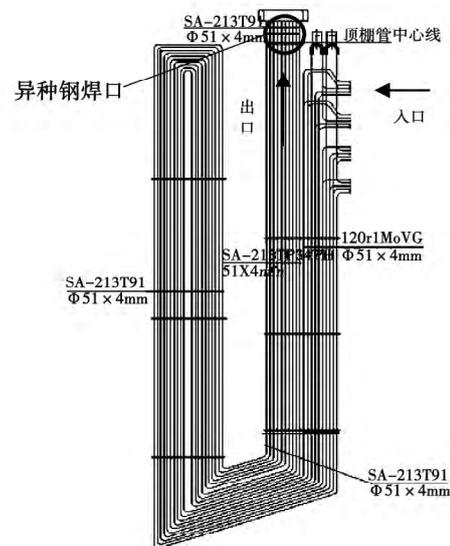
某电厂机组锅炉采用哈尔滨锅炉有限责任公司与三井巴布科克(MB)公司合作设计、制造的超临界本生(Benson)直流锅炉, 型号: HG-1890/25.4-YM4。高温再热器沿炉宽排列 95 片, 横向节距为 230 mm, 管屏中管子间距为 71.1 mm。每片管组采用 10 根管, 入口段管子为直径 57 mm、厚度 4 mm、材料为 12Cr1MoVG, 中间段管子为直径 51 mm、厚度 4 mm、材料为 SA-213 T91, 出口段的管子为直径 51 mm、厚度 4 mm、材料为 SA-213 TP347H, 其中出口段的 TP347H/T91 异种钢焊口位于顶棚下方 50 mm 处, 如图 1 所示。

在运行过程中该处异种钢焊口出现过泄漏, 严重影响机组的安全运行。泄漏的位置在 TP347H 管与 T91 管的焊口处, 且在 T91 管侧沿熔合线下部热影响区处开裂。

图 1 高温再热器爆口位置

针对高温再热器出口异种钢焊口应力集中的问题,将异种钢焊口移至炉顶大包内,减少交变应力的作用,提高锅炉受热面运行的可靠性。并且在T91/TP347H异种钢焊口射线检查合格后进行热处理,热处理加热至 760 ± 10 °C,保温60 min,升降温速度不大于150 °C/h,环境温度不低于5 °C。焊口热处理采用履带加热器,外缠保温棉。

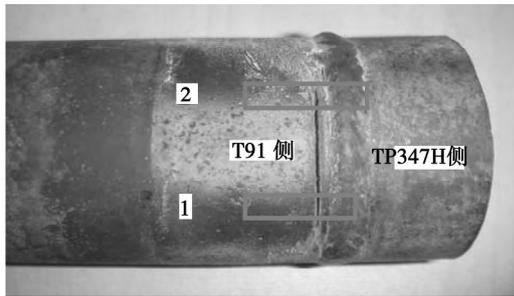
T91 侧 HAZ(热影响区), 距离焊缝边缘约 2 mm, 沿管子周向扩展, 裂纹走向与熔合线平行如图 2 所示。管子外壁裂纹长度约 35 mm, 裂纹张口宽度约 1.5 mm。泄漏管段附近无明显的塑性变形和胀粗现象。查看管子内壁, 发现焊口两侧母材内壁有车削痕迹如图 3 所示, 壁厚相对较薄, 其中 T91 侧内壁有明显氧化皮存在, 而 TP347H 侧没有。

图 2 高温再热器异种钢焊口裂纹

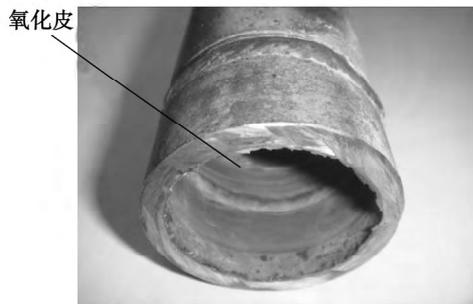
图 3 高温再热器异种钢焊口内壁

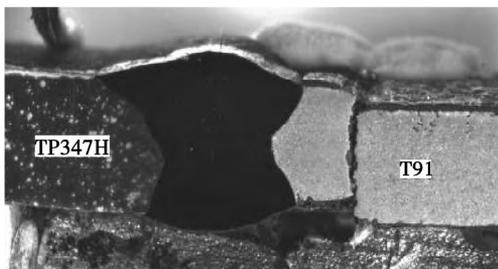
在裂纹最宽处和裂纹边缘横跨焊缝取样 2 只, 分别为试样 1 和试样 2, 试样包括两侧母材和完整焊缝。对试样磨制、抛光、侵蚀后, 在低倍体视镜下观察, 试样 1 中裂纹已完全贯穿, 试样 2 中裂纹自外壁向内壁扩展, 但并未裂穿, 两只试样中裂纹距离焊缝外壁边缘均为 2 mm, 如图 4-图 6 所示。由焊缝坡口形貌来看, 近似为 V 形坡口。焊口两侧母材壁厚略有差异, 实测 T91 侧平均壁厚为 3.3 mm,

图 4 试样 1 整体形貌(×1.0)

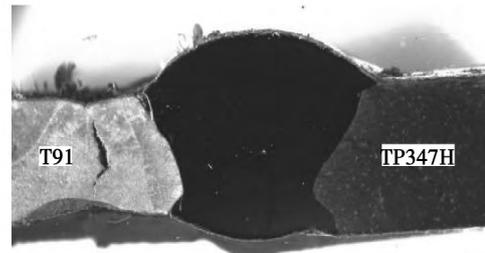
TP347H 侧平均壁厚为 3.7 mm,均略低于 4.0 mm 的设计壁厚,这可能与坡口加工时管子端部内壁车削过有关。并且 T91 侧外壁沿焊缝熔合线部位有一处氧化缺口,深度约 0.8 mm 如图 5 所示。

图 5 试样 2 整体形貌(×1.0)

试样 2 中 T91 和 TP347H 侧母材和焊缝金相组织正常,分布为回火马氏体组织和奥氏体组织,焊缝为单相奥氏体柱状晶组织,且焊缝两侧熔合线处较难侵蚀。焊缝 T91 侧外壁熔合线部位有一处氧化缺口,最大深度约 0.8mm,但该氧化缺口距离裂纹外壁近 2 mm,明显不是裂纹诱因。裂纹同样位于焊缝 T91 侧 HAZ 细晶粒区,裂纹外壁处开口较小,中间较大,并向内壁扩展,距离内壁 0.15 mm,尚未完全

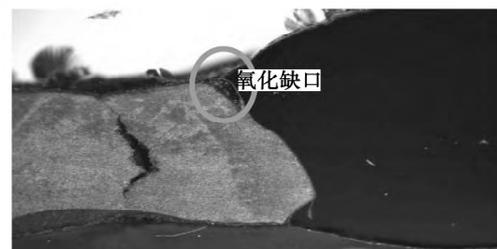
图 6 试样 2 中裂纹放大形貌(×2.0)

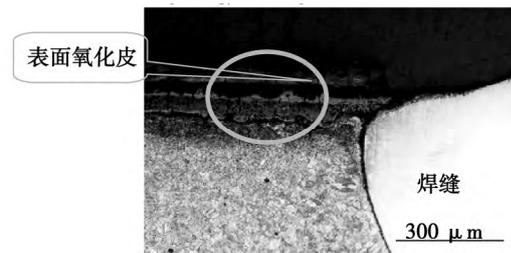
图 10 试样 1 焊缝 T91 侧外壁熔合线形貌(×100)
Fig. 10 Morphology of the fusion line of specimen No. 1 on the outer wall at the side of TP347H steel material(×100)

分析金相试验结果,试样 1 中 T91 和 TP347H 侧母材和焊缝金相组织正常,分布为回火马氏体组织和奥氏体组织,焊缝为单相奥氏体柱状晶组织,且焊缝两侧熔合线处较难侵蚀。图 10 中 T91 侧外壁有明显氧化层,厚度约 0.15 mm。焊缝 T91 侧 HAZ 金相组织依次为马氏体粗晶区→马氏体细晶区→T91 母材,由图 15 可知裂纹位于马氏体细晶区。

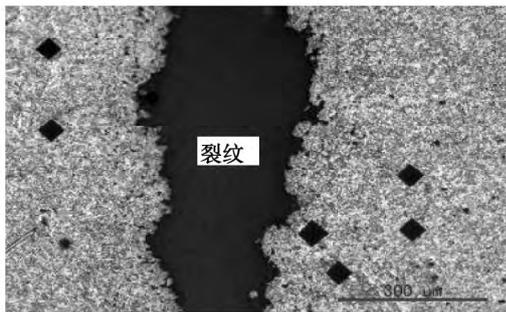
图 15 试样 1 中 T91 侧焊缝 HAZ 细晶区金相组织(×100)

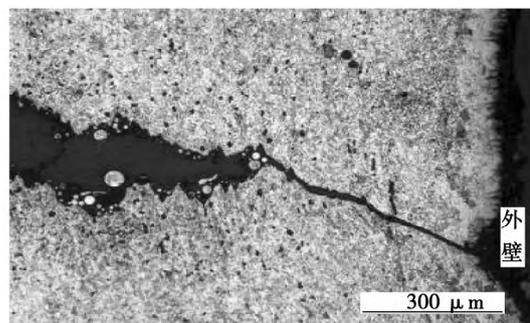
图 19 试样 2 中裂纹外壁金相组织形貌 ×100

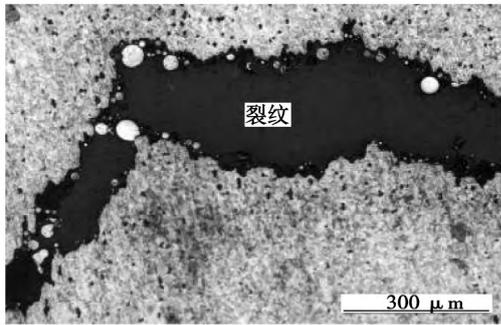
图 20 试样 2 中裂纹中间金相组织形貌(×100)
Fig. 20 Morphology of the metallurgical structure of e cracks on the inner wall of specimen No. 2(×100)

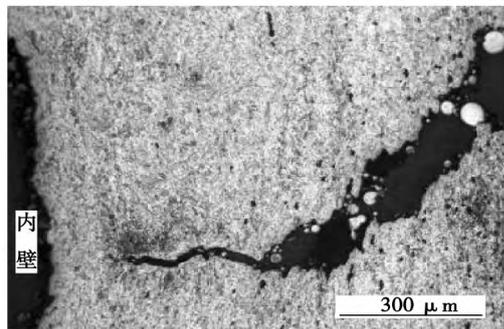
图 21 试样 2 中裂纹内壁金相组织形貌(×100)
Fig. 21 crack wall microstructure morphology of specimen 2(×100)

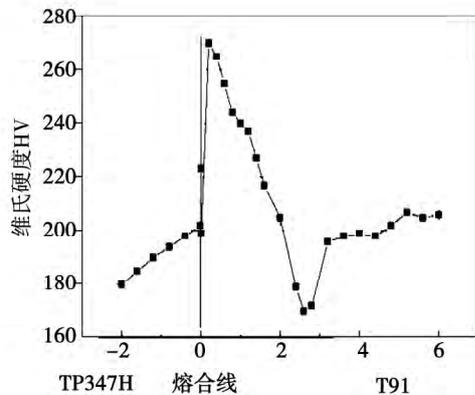
分析显微硬度试验结果, 可见在焊缝 T91 侧 HAZ 粗晶区存在显微硬度峰值, 最高为 270 (N/mm²) HV0.3, 在裂纹两侧显微硬度最低, 分别为 170

(N/mm²) HV0.3 和 172HV0.3 ,出现比较明显的显微硬度低谷。而焊缝 TP347H 侧没有明显的显微硬度起伏。

图 22 试样 1 焊缝向两侧显微硬度分布图
Fig. 22 Chart showing the distribution of the microscopic hardness at both sides of the welding seam of specimen No. 1

显微硬度结果显示,焊缝 T91 侧 HAZ 显微硬度从熔合区向母材逐渐降低,且在接近母材处存在一个明显的软化区。从这一特征分析认为,该焊口焊

后没有进行热处理。焊接后熔合区最接近焊接熔池,温度最高,冷却速度最快,离熔池距离越远,温度越低,冷却速度也越慢,相当于对不同部位进行了一次温度不同的淬火处理,故显微硬度呈现这一变化规律。如果进行了焊后热处理,则显微硬度会相对均匀,硬度差异不会如此明显。裂纹刚好位于焊缝T91侧HAZ软化区薄弱部位上,裂纹两侧显微硬度相最低。而根据DL/T 752-2001《火力发电厂异种钢焊接技术规程》规定,对T91/TP347H类AM组异种钢焊接接头应进行焊前预热、焊后热处理,众多参考文献中关于T91/TP347H异种钢焊接性能和工艺分析研究均强调了焊后热处理的重要性^[2-6]。

综上所述,由于没有进行焊后热处理,热影响区存在一个明显的软化区,性能差强度低,且该焊口处于应力相对集中部位,承受应力值较高的疲劳载荷。在机组启停或负荷变化较大时,首先在该焊接接头HAZ软化区形成微裂纹,并在运行过程中逐步扩展,最终造成泄漏。
