# 某船主锅炉过热器管束爆管原因分析及解决措施

**摘要:** 针对某船主锅炉过热器管束的爆管问题, 对管束材料、过热器结构及系统运行等方面进行试验、计算及分析讨论, 明确了爆管产生的原因——过热器集箱隔板装置因运行操作不当, 突然承受大的压差而变形, 导致蒸汽短路而爆管。为此, 提出了解决措施, 消除了产生爆管的因素。

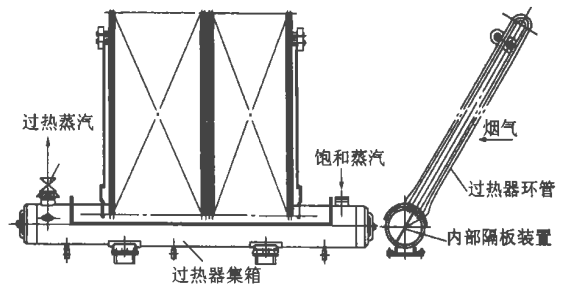
图1 过热器

锅炉型式为立式水管单烟道自然循环燃油船用主锅炉, 具有内置式过热器和翅片管经济器。过热器结构为单集箱立式环管式, 见图1。集箱内部装有横向和纵向隔板, 将集箱内部分隔成三个空间, 见图2。蒸汽按两个流程(每个环管为一个流程)流动。饱和蒸汽进入过热器集箱的1区后, 由于内部隔板装置的阻隔, 蒸汽通过过热器环管进入第2区, 同样蒸汽通过环管又进入第3区, 再由过热蒸汽出口截止阀流向汽轮机。隔板与集箱间采用螺栓连接。过热器管束材质为1Cr19Ni11Nb, 最高使用温度为650℃。
