1890/25.4 - YM4 型锅炉高温再热器 泄漏原因分析与对策

摘要: 针对某电厂国产 600 MW 超临界机组锅炉高温再热器出口异种钢焊口的泄漏情况, 采用直读式光谱分析仪 Spectro SortCCD TSC17 对高温再热器 T91/TP347H 异种钢焊接接头两端母材和焊缝进行化学成分分析, 并且在 LECO300 显微硬度计下观察和测量显微硬度, 利用 Axiovert 200 MAT 金相显微镜观察和分析金相组织, 同时综合管排的结构、爆口的特点进行全面分析, 得出高温再热器出口异种钢焊口泄漏的原因, 有针对性的提出治理方案, 因此对同结构的锅炉有很好的借鉴意义。

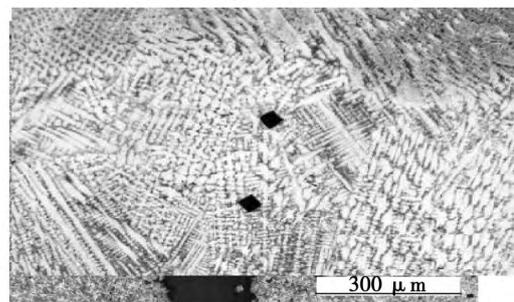
图 7 试样 1 焊缝金相组织(平均显微硬度 223HV0.3) (×100)

分析金相试验结果,试样 1 中 T91 和 TP347H 侧母材和焊缝金相组织正常,分布为回火马氏体组织和奥氏体组织,焊缝为单相奥氏体柱状晶组织,且焊缝两侧熔合线处较难侵蚀。图 10 中 T91 侧外壁有明显氧化层,厚度约 0.15 mm。焊缝 T91 侧 HAZ 金相组织依次为马氏体粗晶区→马氏体细晶区→T91 母材,由图 15 可知裂纹位于马氏体细晶区。

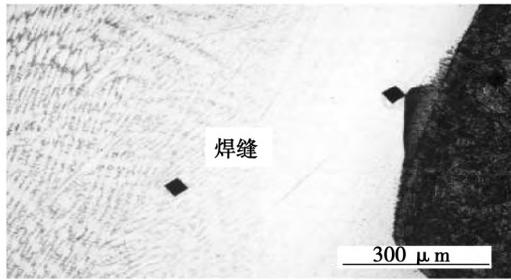
图 8 试样 1 焊缝 T91 侧熔合线形貌(×100)
Fig. 8 Morphology of the fusion line of specimen No. 1 at the side of T91 steel material(×100)

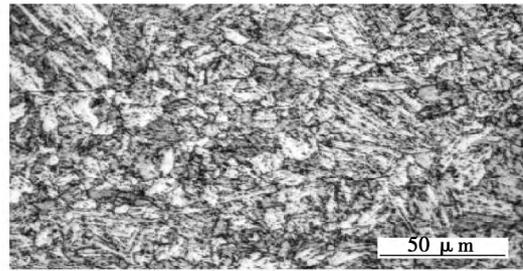
图 11 试样 1 中 TP347H 侧母材金相组织(×200)
Fig. 11 Metallurgical structure of the parent metal of specimen No. 1 at the side of TP347H steel material(×200)

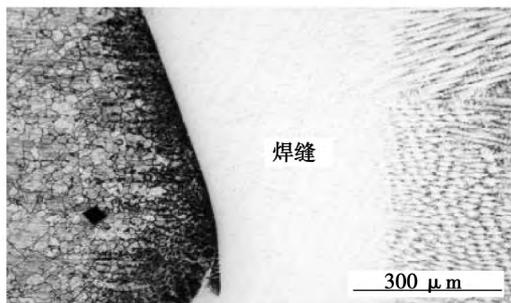
图 9 试样 1 焊缝 TP347H 侧熔合线形貌(×100)
Fig. 9 Morphology of the fusion line of specimen No. 1 at the side of TP347H steel material(×100)

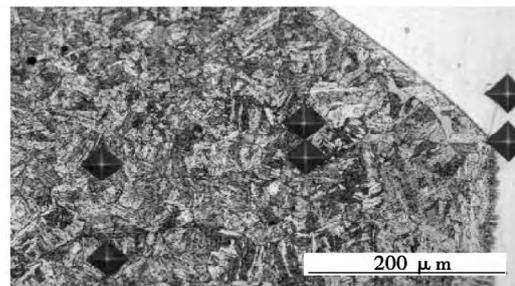
图 12 试样 1 中 T91 侧母材金相组织(×500)
Fig. 12 Metallurgical structure of the parent metal of specimen No. 1 at the side of T91 steel material(×500)

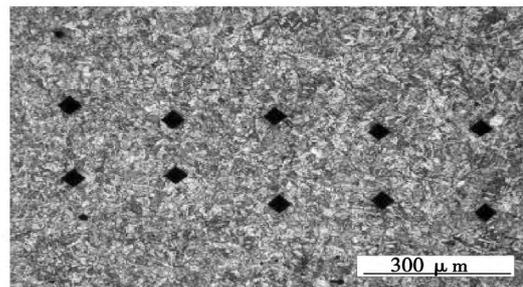
图 13 T91 侧熔合线金相组织(×200)
Fig. 13 Metallurgical structure of the fusion line at the side of T91 steel material(×200)

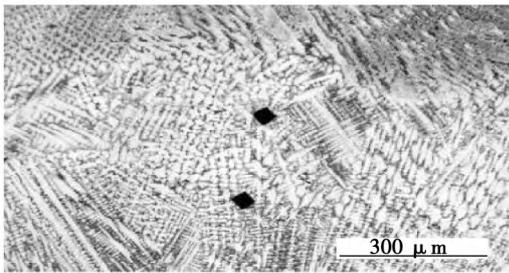
图 14 试样 1 中 T91 侧焊缝 HAZ 粗晶区金相组织(×100)

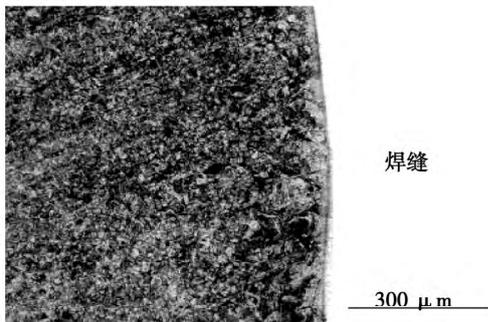
试样 2 中 T91 和 TP347H 侧母材和焊缝金相组织正常,分布为回火马氏体组织和奥氏体组织,焊缝为单相奥氏体柱状晶组织,且焊缝两侧熔合线处较难侵蚀。焊缝 T91 侧外壁熔合线部位有一处氧化缺口,最大深度约 0.8mm,但该氧化缺口距离裂纹外壁近 2 mm,明显不是裂纹诱因。裂纹同样位于焊缝 T91 侧 HAZ 细晶粒区,裂纹外壁处开口较小,中间较大,并向内壁扩展,距离内壁 0.15 mm,尚未完全

图 16 试样 2 焊缝 T91 侧熔合线形貌(×100)

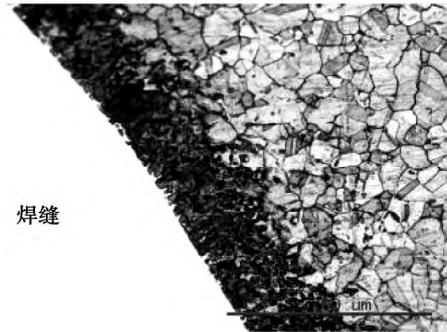
图 17 试样 2 焊缝 TP347H 侧熔合线形貌(×200)

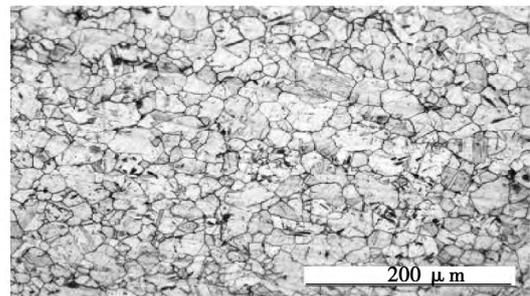
图 18 试样 2 中 TP347H 侧母材金相组织(×200)
